FACTORS INFLUENCING THERMOMECHANICAL FAILURE OF FACE SEALS

Francis E. Kennedy, Jr., John N. Grim and Roger P. Glovsky

Office of Naval Research Contract No. NO0014-81-K-0090 Period Covered: December 1, 1980 to November 30, 1981

January, 1982

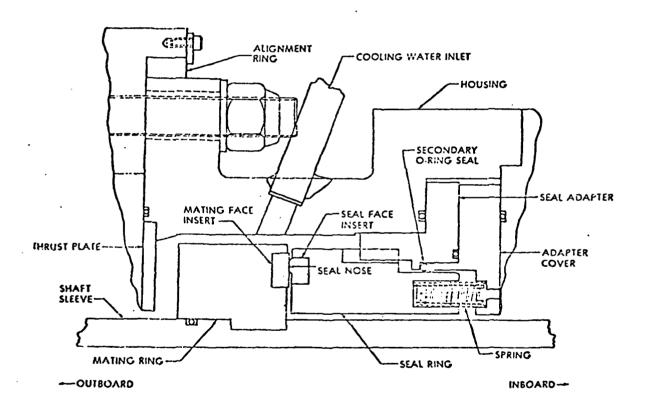
Mechanical face seals have proven to be the most effective means of providing rotary shaft sealing in many severe applications such as the one described. As the severity of the application increases, however, the frequency of seal failure, as indicated by excessive leakage and/or excessive friction, also increases (1). In the newer submarines, for example, many early failures of the large, heavily-loaded primary shaft seals have been encountered. Since such failures can lead to a delay in or curtailment of the vessel's mission, it is necessary that seal failures be avoided, if possible. Upon disassembly of a seal after such a failure it is frequently found that the surface of the metallic mating ring contains numerous cracks. These cracks, called thermocracks or heat checks, contribute to excessive wear of the primary ring, warping of the mating ring, excessive seal leakage, and, occasionally, fracture of the mating ring. The shaft seal shown in Figure 1 has not escaped thermocracking

Figure 1. Primary shaft seal assembly.

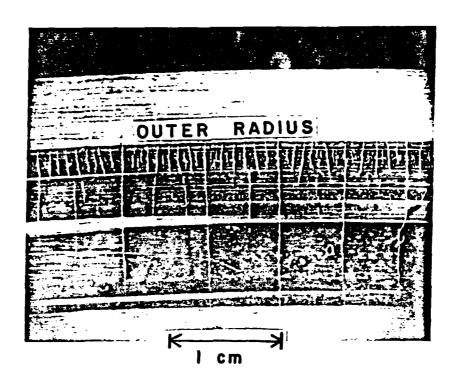
problems. Figure 2 shows the thermocracked surface of a mating ring from that seal. Numerous radial cracks can be observed on the metallic surface, most of which appear to have originated near the outside of the contact interface. One consequence of the thermocracking shown in Figure 2 was excessive seal leakage, which necessitated replacement of the mating ring.

Figure 2. Photograph of mating ring (insert) surface after seal operation.

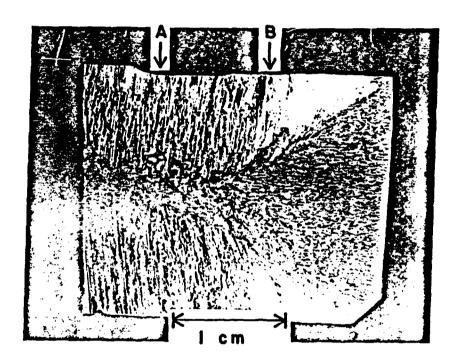
A radial cross-section of a failed mating ring is shown in Figure 3. The cast cobalt-based material has a coarse grain structure, especially near the top, bottom, and outside surfaces where solidification commenced. Many large second phase particles can be observed, especially near the surfaces. Chemical analysis of these particles shows that they are primarily chromium carbides, with some tungsten carbide also being present. Surrounding the carbide particles is a cobalt-rich solid-solution, face-centered cubic in structure. The seal face, which was originally ground flat, shows substantial wear, with the maximum depth of about .5 mm occurring near the seal inside diameter (region A). Less wear was observed near the outside diameter, where cracks are more prevalent (Region B).

Figure 3. Cross sectional view of mating ring insert after seal operation. Cast cobalt-based superalloy, polished and lightly etched.

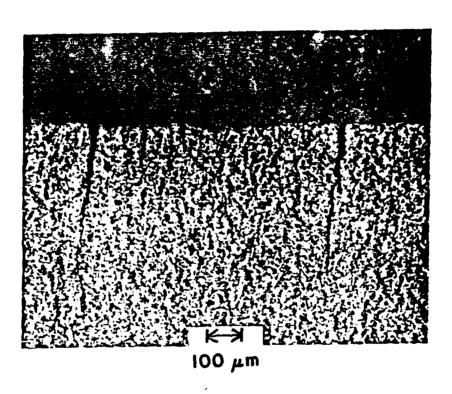
A longitudinal cross-section, cut along a circumferential direction in region B, shows a rather uniform spacing of cracks, all of which appear to be surface-originated (Figure 4). The spacing between cracks can be correlated with the depth of the cracks, with deeper cracks being more widely separated then the shallower cracks. The seal face is not smooth, as can be seen in Figure 4, with substantial surface damage evident in the thermocracked region. Carbon, presumably scraped from the primary seal ring, was present on the surface in the cracked and damaged regions, but was only loosely attached to the mating ring material. A similar slice through region A showed much less surface damage in the region of fewer thermocracks.

Figure 4. Longitudinal view of mating ring insert after seal operation (sectioned along circumferential direction).

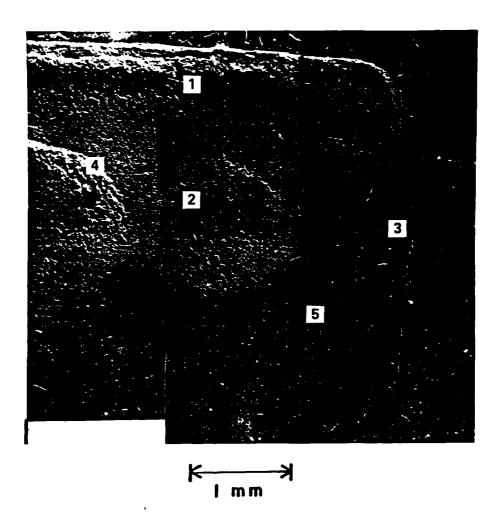
A better view of the surface damage is seen in Figure 5, an SEM micrograph of a mating ring surface. Several regions of the surface show evidence of considerable pitting-type damage (regions 1 and 4). This damage is most visible near the seal face outside diameter. Other regions, such as 2, appear to be zones of concentrated contact.

Figure 5. Scanning electron micrograph of mating ring (insert) surface after seal operation.

That contact region includes a crack. Concentrated contact had reoccurred in the region after the crack formed. Region 3 has a large crack, which extends much of the way across the seal face. Other regions, such as 5, especially near the seal inside diameter, appear to be polished, with little evidence of gross damage.

Close examination of the mating ring surface showed several crack titiation sites across the face, with some cracks, such as 3 in Figure 5, appearing to be formed by a combination of several shorter cracks with different initiation sites. Some of the observed cracks are quite small, either because their growth has been blunted or because the stress was insufficent to cause crack extension. One such microcrack is shown in Figure 6. It was found from Figure 6 and similar micrographs that the cracks tend to begin in the large chromium carbide particles which are visible as dark gray patches. The fracture of the carbides is transgranular in nature, with propagation to other nearby carbides following initiation. If no other carbide particles are close enough, the crack could be blunted in the surrounding ductile cobalt-rich matrix. Another thing evident in Figure 6 is the hole left by removal of a carbide particle. Carbide removal may be responsible for the damage and pitting noted in regions of Figures 4 and 5.

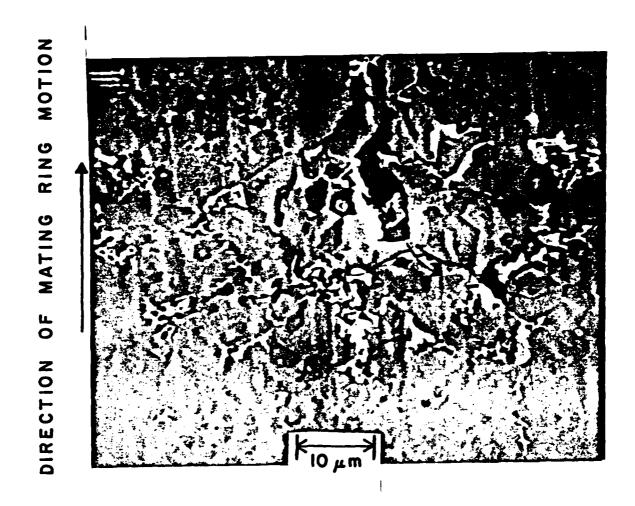
Figure 6. Higher magnification SEM micrograph of mating ring (insert) surface after seal operation.

bond, thus allowing the particle to be removed easily. Both forms of damage were observed in Figure 6. If a crack is formed in the region of residual stress, it would tend to relieve the residual strain energy, lowering the residual stress around it. Thus, a contact patch would have to move a good distance away from a crack before building up a residual stress level sufficient to cause another crack to form. This could account for the spacing between cracks observed in Figures 2 and 3. Thus, the proposed thermocracking mechanism appears to be consistent with all of our microscopic observations.

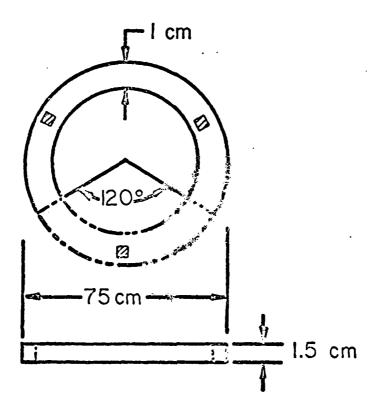
A finite element model of the shaft seal is shown in Figure 8. The dimensions of the primary seal face insert are shown in Figure 7, with the mating ring insert dimensions being identical except for the thickness, which was slightly larger than that of the primary ring. The finite element mesh was two-dimensional (axial and

Figure 7. Sketch of primary seal ring, showing section studied in thermal and stress analyses.

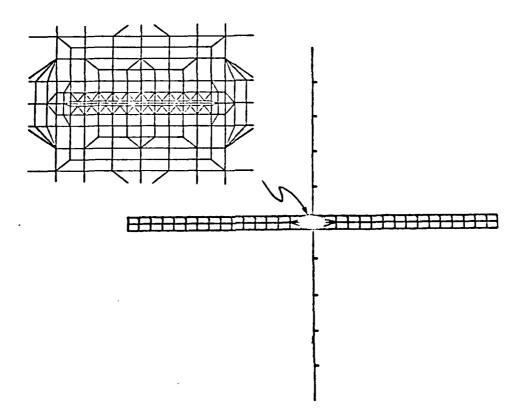
Figure 8. Finite element mesh for shaft seal analysis.

circumferential directions), with variable thickness of the elements being used to account for heat flow in the radial direction. Very fine elements (as small as $10~\mu m \times 30~\mu m$) were used in the contact region, with larger elements being employed further away. A number of different element meshes were tried, with most of the data being generated using a mesh with nearly 700 nodes.

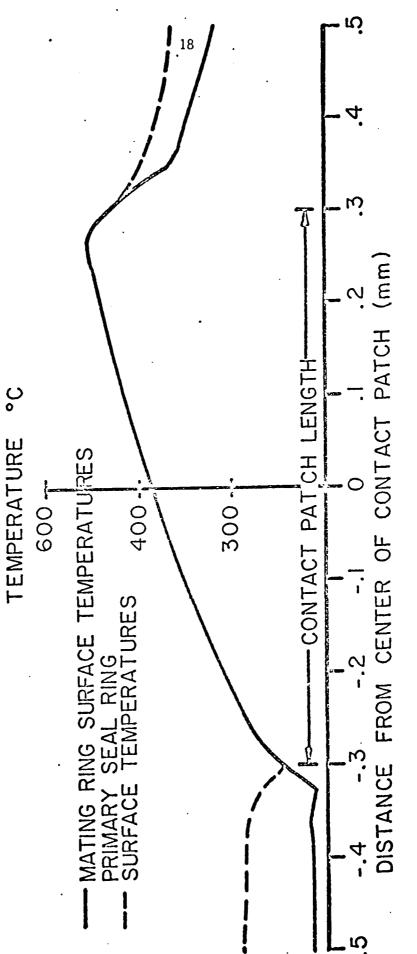
Analyses of this situation were carried out for two cases: contact patch fixed on stationary primary seal ring, and contact patch fixed on moving mating ring. In both cases the mating ring was assumed to be moving at a velocity of 4.7 m/s and interfacial convective cooling was assumed. Surface temperature distributions for the two cases are shown in Figures 9 and 10. In both cases, as in all other temperature analyses done here, the maximum surface temperature occurs within the contact patch near the trailing edge (the mating ring is moving from left to right in Figure 9 and from right to left in Figure 10). The maximum temperature is more than 40% higher when the contact patch is moving with the mating ring (Figure 10) than when the patch is stationary on the primary ring (Figure 9). This is primarily because the mating

Contact patch stationary with primary ring. Uniform heat generation Surface temperature distribution near contact patch in shaft seal. within patch. $q_{total} = 445 \, \text{W}$, Velocity of mating ring = 4.7 ms⁻¹ Interface cooling.

The more effective cooling of the mating ring is especially apparent near the leading edge of the contact zone. In both Figures 9 and 10 it can be seen that the mating ring surface tends to be cooler away from the contact patch than does the primary ring. This causes the contact patch temperature to be lower in the case of Figure 9, where the mating ring enters the contact patch and actually cools the primary ring surface.

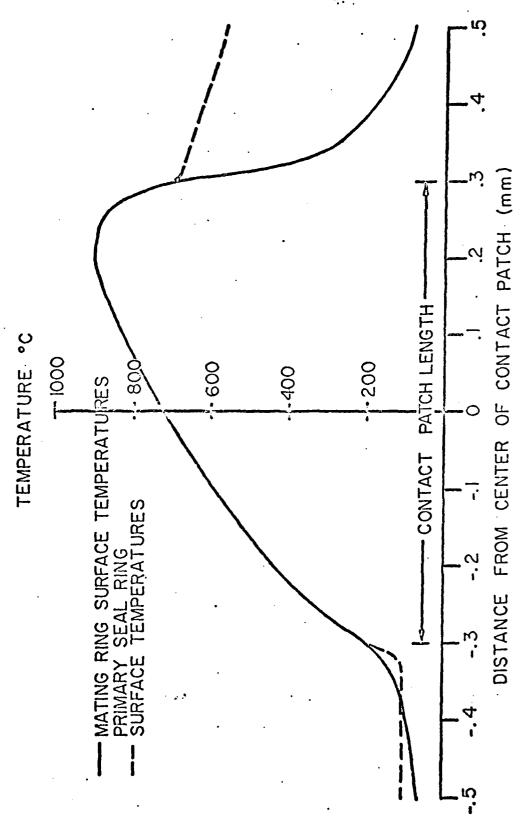
tact patch moving with mating ring. Uniform heat generation within patch. Figure 10. Surface temperature distribution near contact patch in shaft seal. Con- $Q_{total} = 445 \text{ M}$, Velveity of mating ring = 4.7 ms⁻¹. Interface cooling.

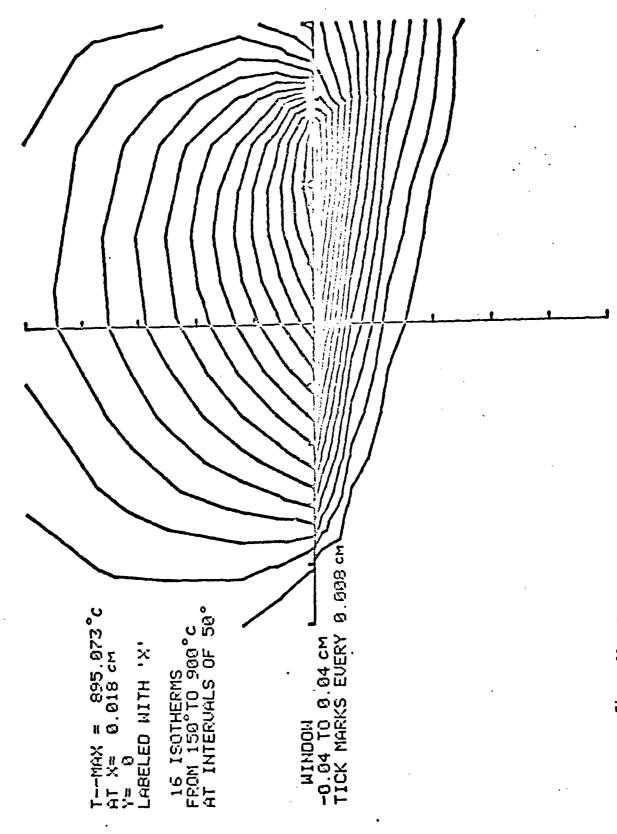
The high temperatures in the contact patch are very localized, as can be seen from Figure 11, which shows isotherms in both bodies for the same case as was shown in Figure 10. In Figure 11, the mating ring, shown at the top, is moving at a velocity of 4.7 m/s from right to left. The contact patch, which extends from x = -0.03 cm to x = +0.03 cm, it is moving with the mating ring. It is evident that temperature gradients in the y direction are larger in the body which is moving relative to the contact patch (in this case the primary ring). One also notes, however, the very severe temperature gradient which occurs on the mating ring surface just to the right of the contact patch. These temperature gradients are important because of their influence on thermal stresses, as will be shown.

Figure 11. Isotherms in mating and primary rings for case of Figure 10.

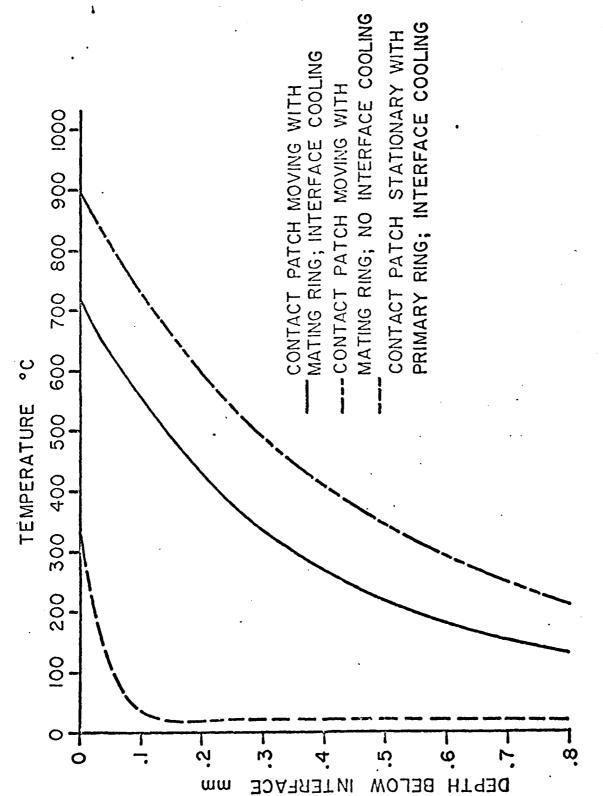
Another indication of the relative temperature gradients is shown in Figure 12. Temperatures in the mating ring insert are shown as a function of depth below the center of the contact patch. Comparison is made between three cases: contact patch fixed on moving mating ring, with and without interfacial cooling; and contact patch fixed on stationary primary ring, with interfacial cooling. It can be seen that the most severe axial direction temperature gradients in the mating ring occur in the case when the mating ring is moving with respect to the contact patch, even though the surface temperature magnitudes are lower for that case. The region affected by high temperatures is much larger in the cases where the contact patch is fixed on the mating ring, both because of the higher surface temperatures in that case and

Figure 12. Temperatures within mating ring insert along line through centerline of contact patch. Uniform heat generation within contact patch. 445 W, Velocity of mating ring = 4.7 ms⁻¹

because of the less severe temperature gradients. Interfacial cooling lowers the temperatures significantly, and also lowers temperature gradients.

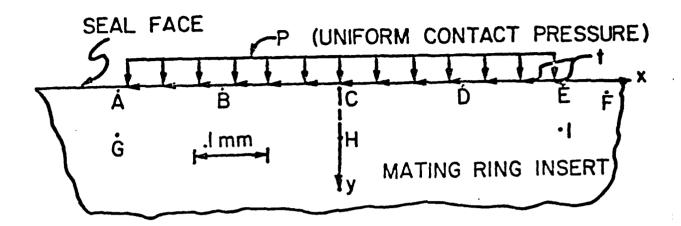
It can be seen from Figure 13 that σ_{χ} , the stress component which would cause radial cracks like those found in Figure 2, is everywhere compressive. The reason

It can be noted from Figure 13 that the effective stress near the contact patch is quite high. In fact, the effective stress determined in this thermoelastic analysis is much higher than the yield stress, which is estimated to be about 380 MPa for this material. It must be concluded, therefore, that significant plastic deformation can be expected in the region of the contact patch.

Figure 13. Stress distribution within mating ring insert. Conditions same as in Figure 10, except no interface cooling.

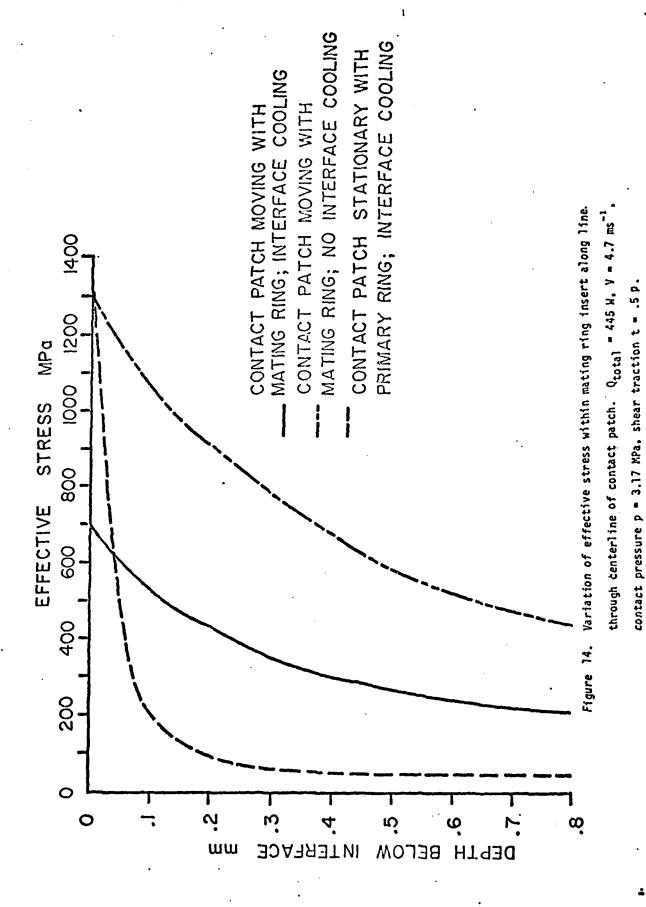
The region of high $\bar{\sigma}$, and therefore the region in which plastic deformation would occur, is concentrated near the contact patch, as can be seen in Figure 14. By comparing Figure 14 with Figure 12, one can see that the region of high stress is about the same as the region of high temperature. This is to be expected since the

dominant contribution to stress is thermal stress. It can also be seen that the lower temperatures found in the situation when the contact patch was fixed on the stationary ring did not guarantee lower stresses in that case. The more severe temperature gradients near the surface in that case led to high stresses (about 85% higher than in the case where the patch was fixed on the moving mating ring). That high stress occurs only very close to the contact surface, however. It can also be seen in Figure 14 that interfacial cooling results in a significant drop in stress levels. This may explain why interfacial cooling has been found to reduce the incidence of thermocracking (9).

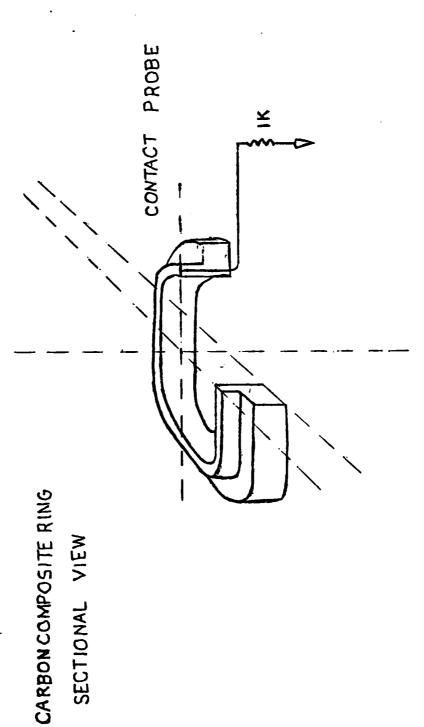
In order to determine the presence of TEI-induced contact patches, an electrical contact probe was designed and built. The probe consists of a fine wire implanted in, but insulated from, the stationary seal ring. Figure 15 shows a typical probe loaction in a carbon primary ring, which during initial tests served as the stationary ring. To implant the contact probe a .5 mm diameter hole was drilled in the ring and a .45 mm diameter copper wire, with surrounding epoxy insulation, was embedded in the hole (Figure 16). Against the outer edge of the rotating stainless steel a carbon brush was placed to provide electrical current for the probe. The brush and

FIGURE 15. Schematic diagram of carbon primary seal ring with embedded contact probe.

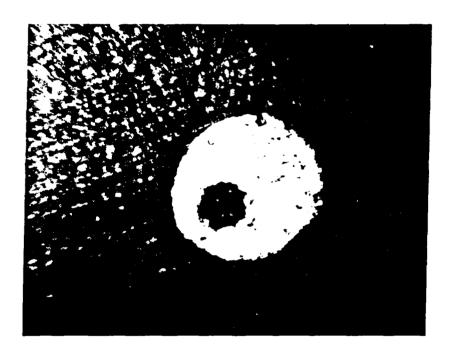
FIGURE 16. Photograph of contact probe wire at contact surface of carbon ring. (100X)

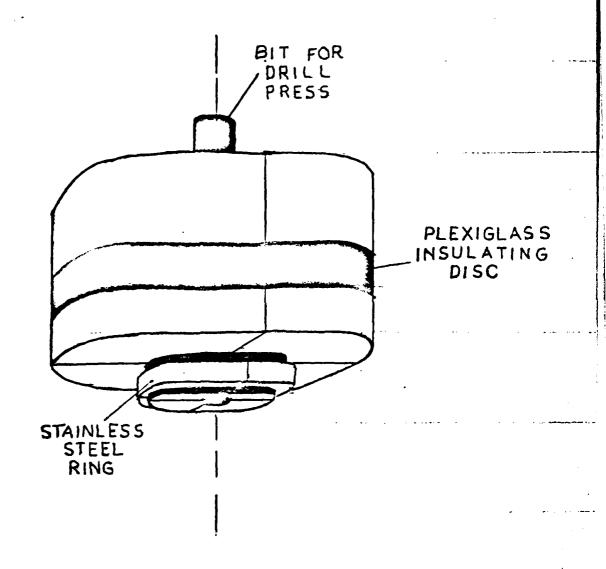
FIGURE 18. Schematic diagram of holder for rotating stainless steel mating ring.

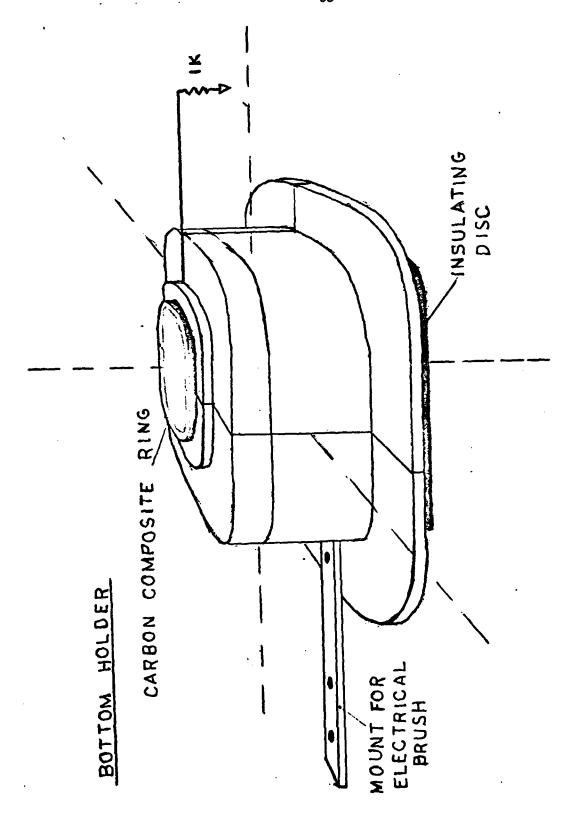
Schematic diagram of holder for stationary carbon primary seal ring. FIGURE 19.

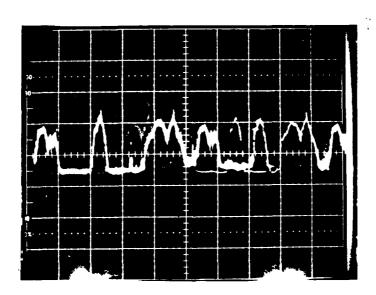
FIGURE 20. Contact probe output at 20 rev/sec, early during test (horizontal scale: 10 msec/div, vertical scale: 2 V/div).

between the moving ring and the stationary probe wire is indicated by voltage peaks. The test was run dry at a speed of 20 rev/sec (or 50 msec/rev). It can be seen that three contact patches or bumps are present on the mating ring surface and seem to be rotating with it. The patches do not appear to be identical, with one of them extending over about one-fourth of the ring surface. The problem mentioned earlier concerning current leakage from carbon ring to contact probe wire is demonstrated in Figure 21. The signals from the contact patches themselves remain unaltered while the voltage level of the non-contacting region continually rises.

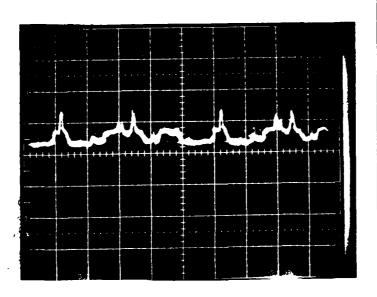
FIGURE 21. Contact probe output at 20 rev/sec, later in test. (horizontal scale: 10 msec/div, vertical scale: 2 V/div).

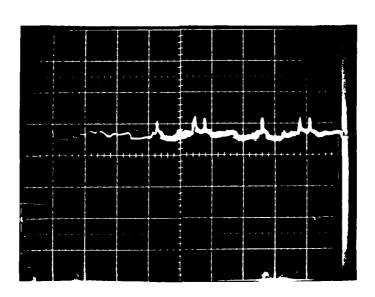
The influence of velocity on thermoelastic instabilities is shown in Figure 22. That trace was taken from a test run at 30 rev/sec (33 sec/rev), with all other conditions being the same as in test of Figures 20 and 21. It can be seen that there are still three contact patches on the mating ring surface and rotating with that ring. The patches appear to be sharper (smaller) than those in the slower tests.

FIGURE 22. Contact probe output at 30 rev/sec, (horizontal scale: 10 msec/div, vertical scale: 2 V/div).
